GigaDevice Semiconductor Inc.

Device Limitations of GD32H73x/H75x

Errata Sheet

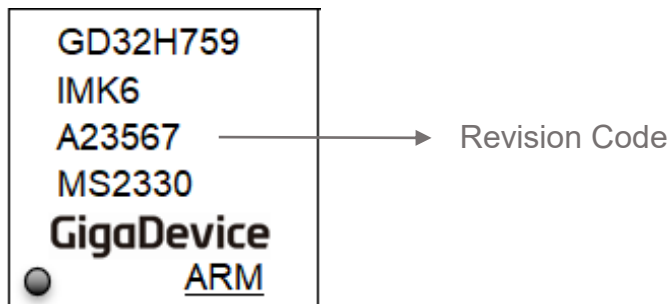
Figure 1-1. Device revision code of GD32H73x/H75x

The device revision can be identified according to the mark on the top of the package. The 1st code on Line 3 of the mark is the product revision code, as shown in [Figure 1-1. Device revision code of GD32H73x/H75x](#).
