GigaDevice Semiconductor Inc.

Device limitations of GD32F45x/F40x

Errata Sheet

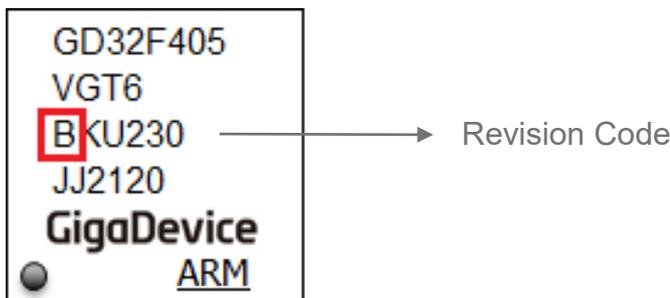
Figure 1-1. Device revision code of GD32F45x/F40x

The device revision can be determined by the mark on the top of the package. The 1st code on the line 3 of the mark represents product revision code. As the picture shown in [Figure 1-1. Device revision code of GD32F45x/F40x](#).
