GigaDevice Semiconductor Inc.

Device Limitations of GD32A503

Errata Sheet

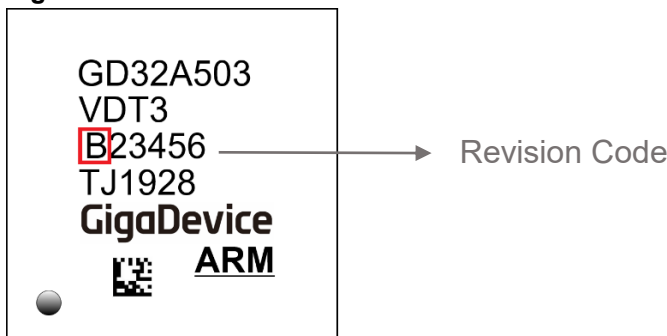
Figure 1-1. Device revision code of GD32A503

The device revision can be identified according to the mark on the top of the package. The 1st code on Line 3 of the mark is the product revision code, as shown in [Figure 1-1. Device revision code of GD32A503](#).
