GigaDevice Semiconductor Inc.

Device limitations of GD32C231

Errata Sheet

Revision 1.1

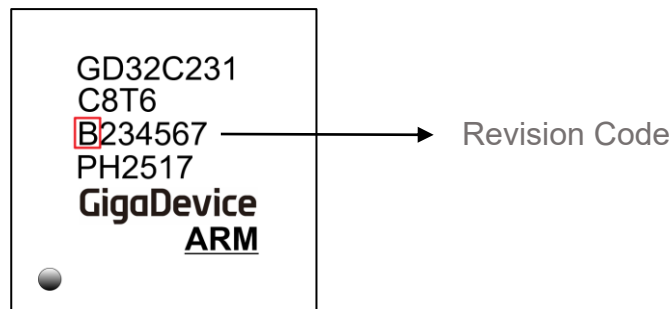
Figure 1-1. Device revision code of GD32C231

The device revision can be identified according to the mark on the top of the package. The 1st code on Line 3 of the mark is the product revision code, as shown in [Figure 1-1. Device revision code of GD32C231](#).
