**GigaDevice Semiconductor Inc.**

**Device limitations of GD32F47x/F42x**

## **Errata Sheet**

Revision 1.5

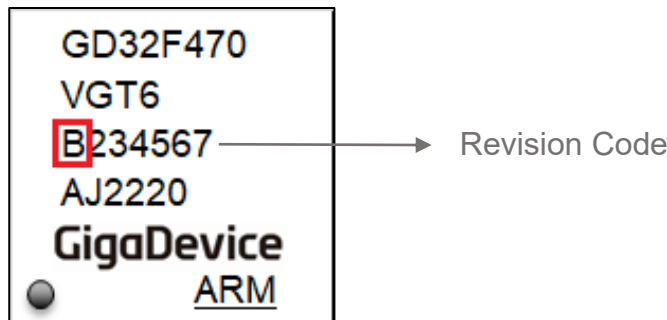
**Figure 1-1. Device revision code of GD32F47x/F42x**

The device revision can be determined by the mark on the top of the package. The 1st code on the line 3 of the mark represents product revision code. As the picture shown in [Figure 1-1. Device revision code of GD32F47x/F42x](#).
